TECHNICAL REPORT REMR-CO-3

**CASE HISTORIES OF CORPS BREAKWATER
AND JETTY STRUCTURES**

Report 6

NORTH PACIFIC DIVISION

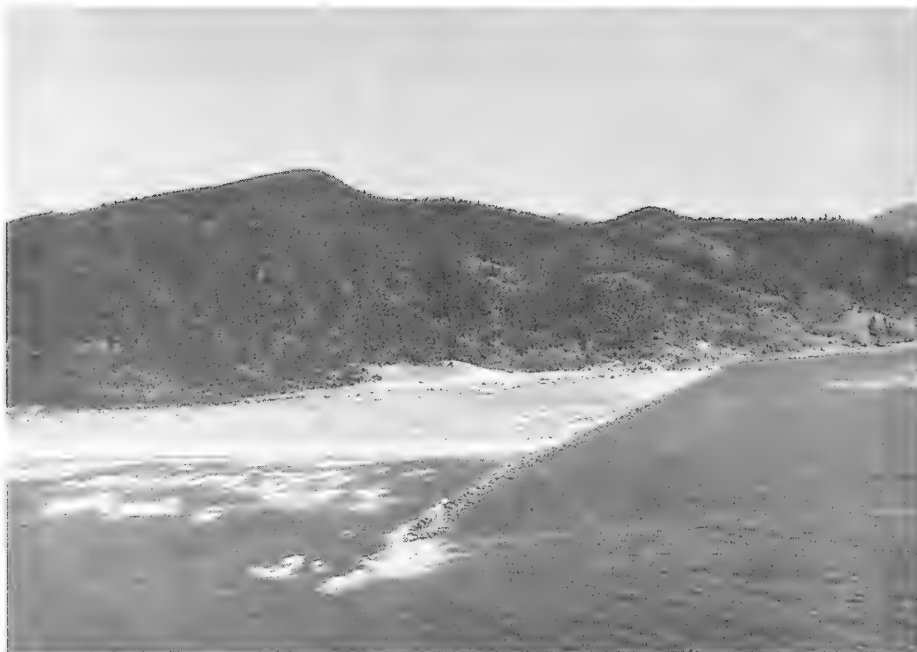
Figure 62. Aerial photograph of north jetty, Tillamook Bay, Oregon, 1955

| <u>Date(s)</u> | <u>Construction and Rehabilitation History</u> |
|---|--|
| 1955 | Repairs were made to the north jetty near the shore end. Also, a breach at the beachline of the north jetty that had been cut to bring a beached vessel through the jetty was repaired. Repair work used 5,535 tons of rock. A 1955 aerial photograph of the north jetty is given in Figure 62. |

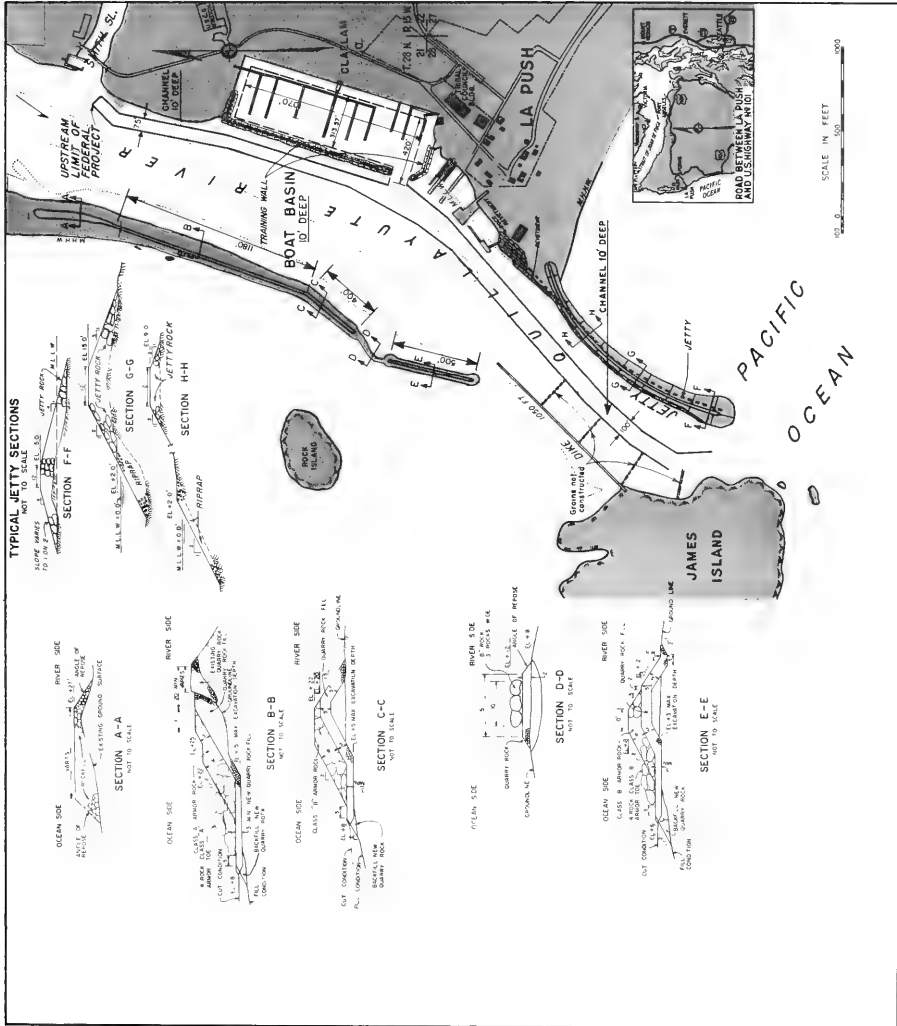
Figure 77. Site layout at Quillayute River, Washington (revised 1982)

| Date(s) | Construction and Rehabilitation History |
|---|---|
| 1985 | The harbor and cross sections of the jetty are illustrated in Figure 77. The outer 250 ft of jetty was lowered to a point that the jetty was awash at high tides. Repair or rehabilitation is not anticipated in the near future. |

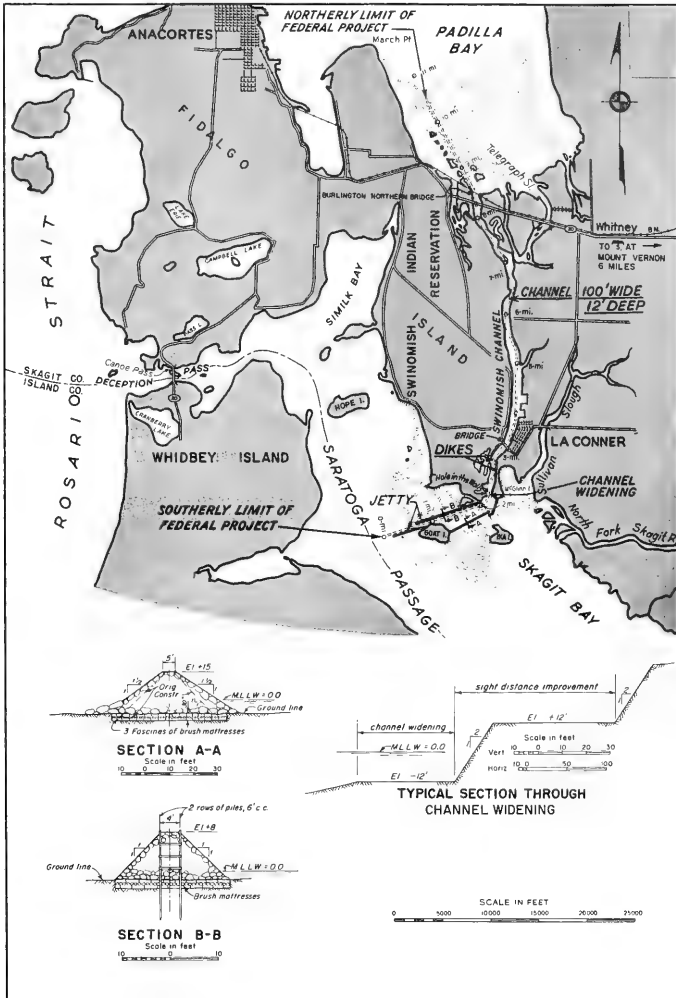
Figure 79. Site layout of Swinomish Channel, Washington (revised 1979)

1985 The jetty layout and cross sections of the jetties are illustrated in Figure 79. The north jetty shows obvious deterioration, and the south jetty and Goat-McGlinn Island jetty appear in good condition.

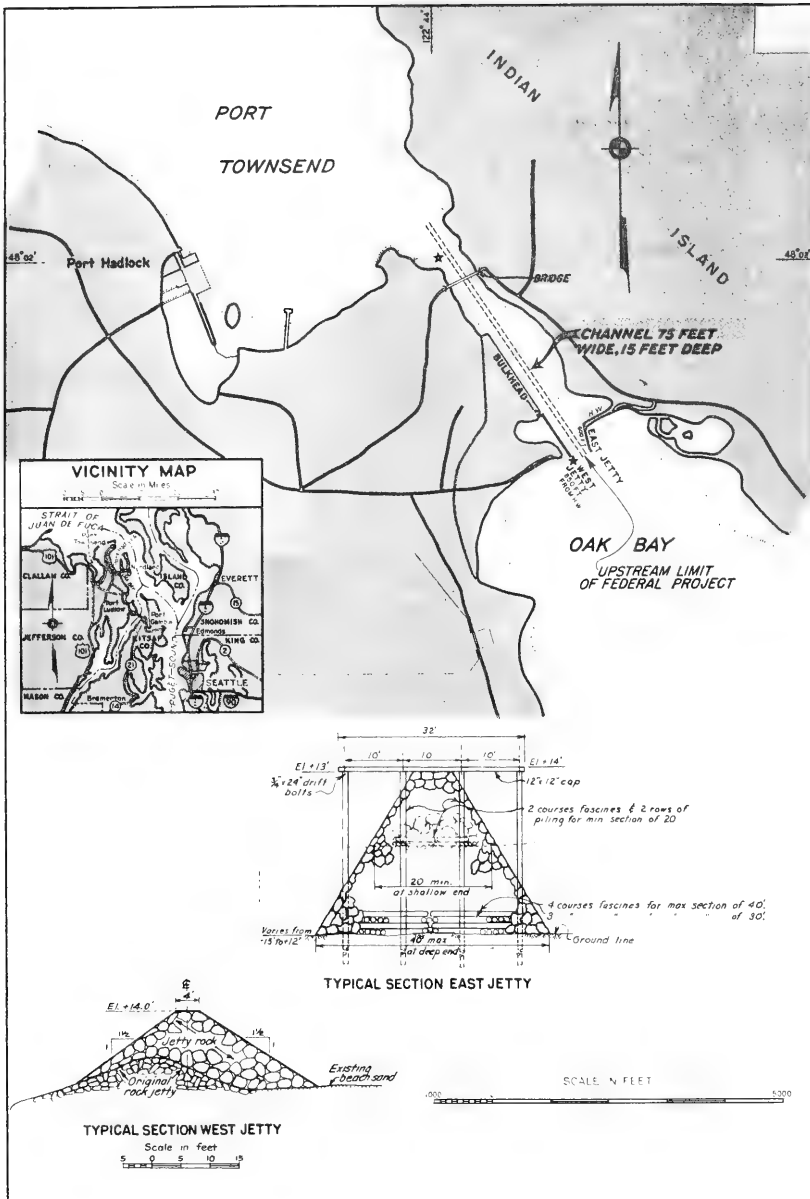
Figure 80. Site layout of waterway connecting Port Townsend and Oak Bay, Washington (revised 1979)

| <u>Date(s)</u> | <u>Construction and Rehabilitation History</u> |
|---|---|
| 1985 | The jetty layout and cross sections are illustrated in Figure 80. There is no record of repairs or rehabilitation since 1961. The west jetty is in good condition. The east jetty shows some deterioration but is stable and functional. |

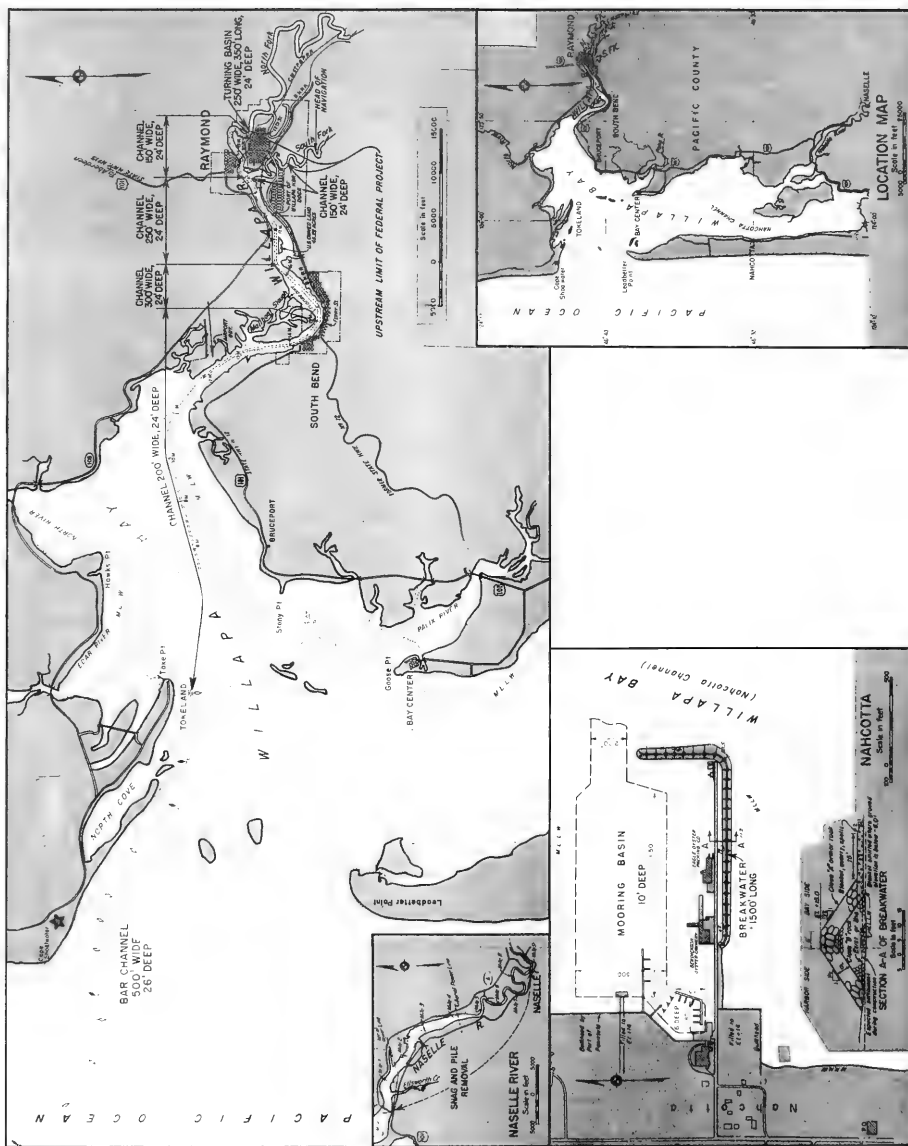
Figure 82. Site layout of Willapa River and Harbor and Naselle River, Washington (revised 1979)

| <u>Date(s)</u> | <u>Construction and Rehabilitation History</u> |
|---|--|
| 1985 | The harbor layout and breakwater cross sections are illustrated in Figure 82. There are no reports of needed repairs or rehabilitation for the breakwater. |
